## Mitigation Measures Alleviate Drainage Problem

### Full Mitigation Best Practice Story

#### *Tarrant County, Texas*

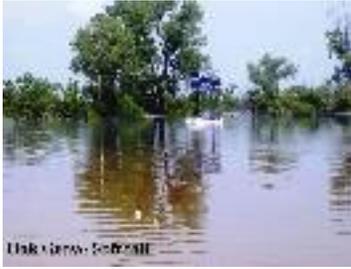
Floodwaters inundated the softball field at Oak Grove Park

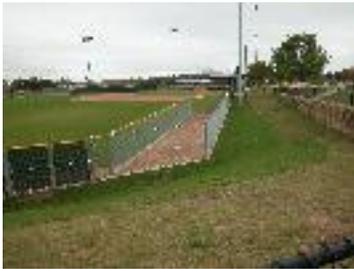
Drainage ditch channels surface water into Lake Grapevine

By nature, stormwater collects debris, chemicals, dirt, and other pollutants before flowing into a storm sewer system or directly to a lake, stream, river, or wetland. Hence, the planners utilized stormwater management as a tool to prevent this debris from entering the water system. “We used storm sceptors, something new to the project, to separate the sand, silt, and clay and keep debris from going back into the lake,” said Mitchell. The sceptors allow water to enter into a swirl chamber where it is filtered before moving into a “floatable” chamber. There, general debris are collected before the water is sent to the outlet chamber for disbursement into Lake Grapevine. Berms were created as an additional filtering system, allowing water to flow through grassy areas that serve as a bio-filtering system before it reaches the lake.

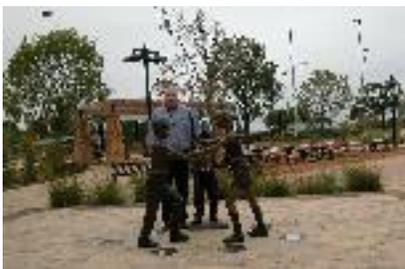
Photo of Kevin Mitchell, Assistant Director of Parks standing alongside statue erected by a local artist. Stone pavers are also shown

Stone pavers created a solid surface for sidewalks, but allowed natural drainage and migration of water into the earth by permitting water to drain through the spaces between the pavers.
